**Flood Control Project Maintenance
Levee Inspections**

Fall 2016 Levee Maintenance Deficiency Summary Report

San Joaquin River Basin

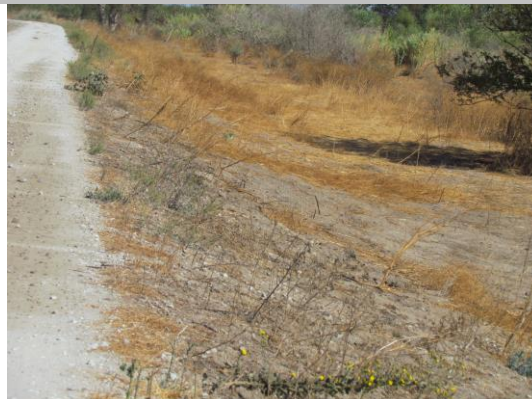
Photo 1 of 1 : FA_2016_NA0011_142_13_20161011_00027.jpg

LM Start	0.03	Rating **	M	Issue No.	13
LM End	0.28	Issue Type +	Ma	Location *	WS
Category	Earthen Levee			GPS Latitude/Longitude	
				Start	End
Item	Vegetation			37.046572 °	37.047760 °
				-120.427470 °	-120.423238 °
DWR ID	DWR_NA0011_01_f_2016_13				
Comment Code					
V1 : Control annual grass and weeds on the levee slopes and easements.					
Inspector Comment					
Control the wild annual grasses and weeds on the waterside slope, looking upstream from levee miles 0.03- 0.28.

Unit 1 looking upstream from levee miles 0.03-0.28.wateside slope.

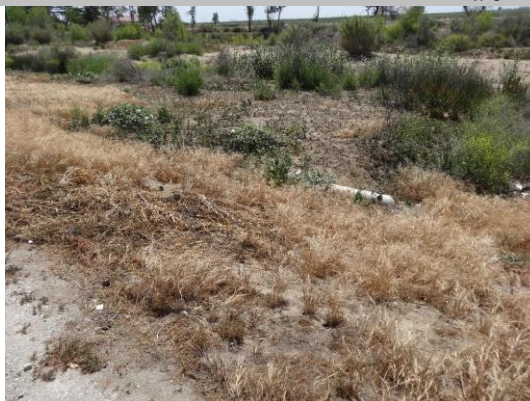
Photo 1 of 2 : UCIP_FA_2016_49976_69674.jpg

FS_ID:49976
DS_ID:21513
EP_NO: N/A
Repair Type: Urgent
Crossing Status: Found
UCIP Comments: 7/14/2016 No inspection completed--need to inspect October 2016. (DWR UCIP - omagana)5/06/2014 Landward slope has been excavated and a berm built in front of landward headwall. Sediment visible inside pipe from landward side. Dense vegetation limits the inspector's visibility to identify signs of pipe failure (leaks) along the waterward slope. Recommend removing vegetation along pipe alignment and waterward headwall to conduct proper inspection of structure. (DWR UCIP - omagana)
FIELD_STRUCT_DESC: 30-inch corrugated metal drainage pipe through the levee, 9.5 feet below the crown. Headwalls and wingwalls are located on both waterside (WS) and landside (LS) ends. Flap gate is located on the WS end. [Additional Reference(s): DWR Levee Log, 2005]
FS Date: 7/14/2016

View of WS--dense vegetation along WS slope.

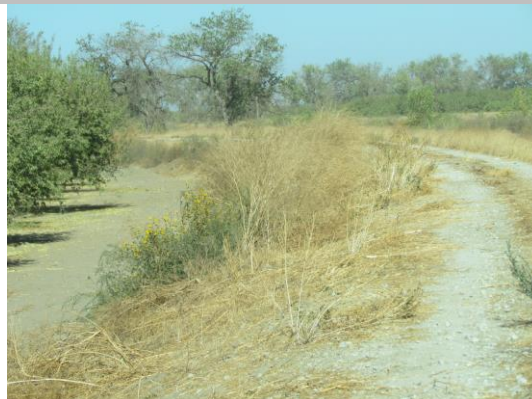
Photo 1 of 1 : FA_2016_NA0011_142_24_20161010_00025.jpg

LM Start	0.61	Rating **	U	Issue No.	24
LM End	0.77	Issue Type +	Ma	Location *	LS
Category	Earthen Levee			GPS Latitude/Longitude	
				Start	End
Item	Vegetation			37.051077 °	37.053122 °
				-120.419003 °	-120.417500 °
DWR ID	DWR_NA0011_01_f_2016_24				
Comment Code					
V2 : Remove the wild growth other than native grasses from the levee slopes.					
Inspector Comment					
Remove the tall weeds from the landside slope

Unit 1 landside levee mile 0.61-0.77 looking upstream of slope.

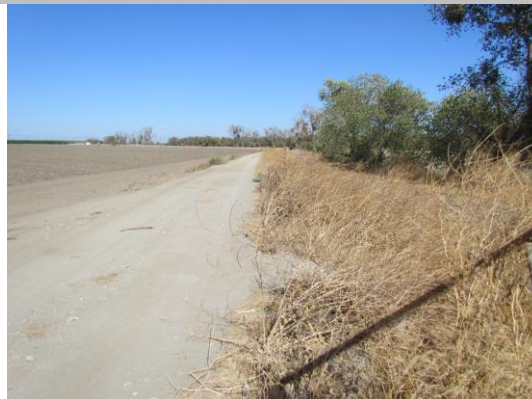
Photo 1 of 1 : FA_2016_NA0011_142_29_20161010_00026.jpg

LM Start	2.09	Rating **	U	Issue No.	29
LM End	2.22	Issue Type +	Ma	Location *	WS
Category	Earthen Levee			GPS Latitude/Longitude	
				Start	End
Item	Vegetation			37.065538 °	37.066700 °
				-120.400862 °	-120.398900 °
DWR ID	DWR_NA0011_01_f_2016_29				
Comment Code					
V2 : Remove the wild growth other than native grasses from the levee slopes.					
Inspector Comment					
Remove the tall dead weeds from the levee slope waterside.

Unit 1 Ash Slough looking upstream levee mile 2.09-2.22.

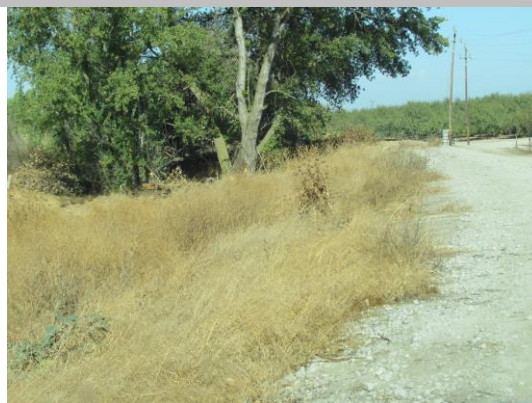
Photo 1 of 1 : FA_2016_NA0011_143_18_20161011_00033.jpg

LM Start	0.22	Rating **	U	Issue No.	18
LM End	1.38	Issue Type +	Ma	Location *	WS
Category	Earthen Levee			GPS Latitude/Longitude	
				Start	End
Item	Vegetation			37.046568 °	37.057948 °
				-120.423588 °	-120.409760 °
DWR ID	DWR_NA0011_02_f_2016_18				
Comment Code					
V2 : Remove the wild growth other than native grasses from the levee slopes.					
Inspector Comment					
Remove the unwanted wild dead weed growth from the waterside levee slope.

Unit 2 Ash Slough looking upstream waterside slope and shoulder levee miles 0.22-1.38.

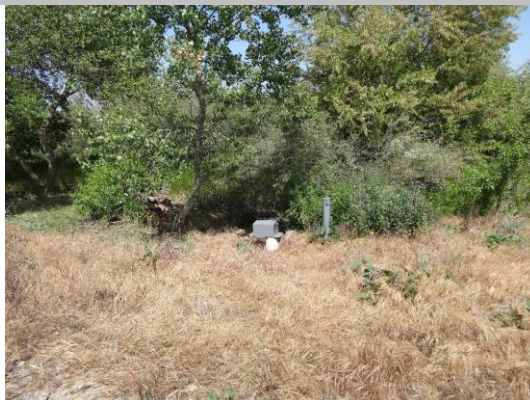
Photo 1 of 2 : UCIP_FA_2016_35764_64463.jpg

Comment Code					
Inspector Comment					
FS_ID:35764					
DS_ID:21514					
EP_NO: N/A					
Repair Type: Non-Urgent					
Crossing Status: Found					
UCIP Comments: Need to contact owner to determine details of crossing and permit information authorizing crossing. Dense vegetation limits the inspector's visibility to identify signs of pipe failure (leaks) along the slope. Recommend removing vegetation along pipe alignment to conduct proper inspection of structure and appurtenances.					
FIELD_STRUCT_DESC: Pipe through levee at a skew. Concrete discharge structure at waterward end. Standpipe with gage house landward of the levee. No gage house found on landward side.					
FS Date: 5/6/2014

View of waterward side.

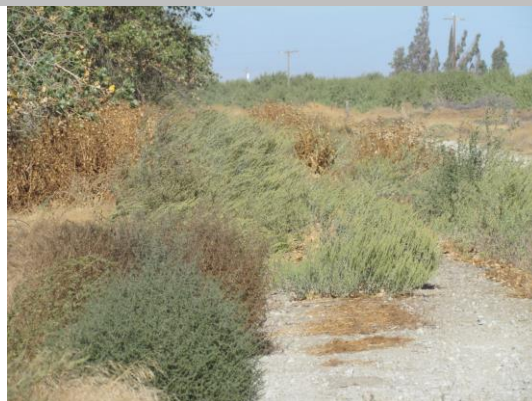
Photo 1 of 1 : FA_2016_NA0011_143_26_20161005_00028.jpg

LM Start	0.32	Rating **	U	Issue No.	26
LM End	0.49	Issue Type +	Ma	Location *	CR
Category	Earthen Levee			GPS Latitude/Longitude	
				Start	End
Item	Vegetation			37.047338 °	37.049035 °
				-120.422062 °	-120.419928 °
DWR ID	DWR_NA0011_02_f_2016_26				
Comment Code					
V9 : Keep the crown roadway free of vegetation.					
Inspector Comment					
Levee crown roadway should be free of vegetation. Spray to sterilize weed growth.

Looking upstream Crown roadway levee mile 0.2-0.49.

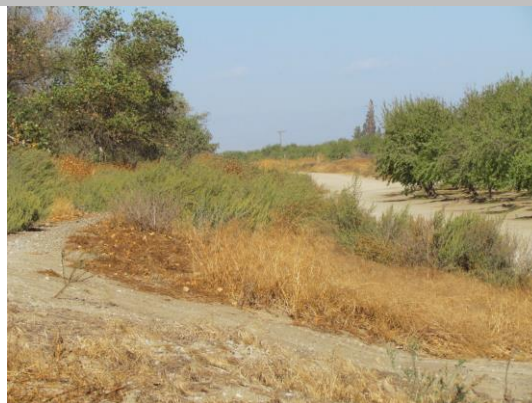
Photo 1 of 1 : FA_2016_NA0011_143_24_20161011_00036.jpg

LM Start	0.32	Rating **	U	Issue No.	24
LM End	0.96	Issue Type +	Ma	Location *	LS
Category	Earthen Levee			GPS Latitude/Longitude	
				Start	End
Item	Vegetation			37.047338 °	37.054705 °
				-120.422062 °	-120.415738 °
DWR ID	DWR_NA0011_02_f_2016_24				
Comment Code					
V1 : Control annual grass and weeds on the levee slopes and easements.					
Inspector Comment					
Control the wild weeds on the landside levee slope and shoulder.

Unit 2 looking upstream from levee mile 0.32 to levee mile 0.96 landside.

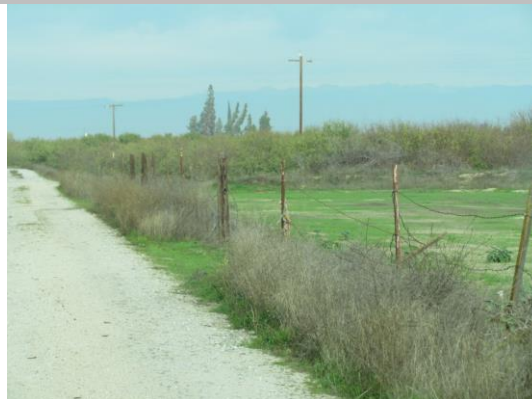
Photo 1 of 1 : FA_2016_NA0011_143_11_20161004_00004.jpg

LM Start	0.45	Rating **	M	Issue No.	11
LM End	0.53	Issue Type +	En	Location *	LS
Category	Earthen Levee			GPS Latitude/Longitude	
				Start	End
Item	Encroachments			37.048627 °	37.049342 °
				-120.420357 °	-120.419370 °
DWR ID	DWR_NA0011_02_s_2012_11				
Comment Code					
FE : Fence					
Inspector Comment					
Wire fence on the landside levee shoulder along with unwanted tall weed growth..

Fence on the landside slope.

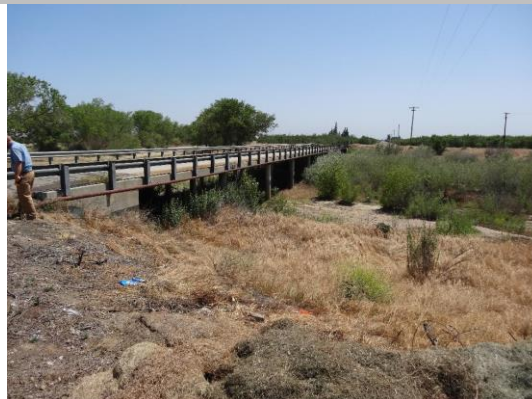
Photo 1 of 2 : UCIP_FA_2016_39923_71823.jpg

LM Start	0.94	Rating **	M	Issue No.	49
LM End	0.94	Issue Type +	En	Location *	WS
Category	Supplemental			GPS Latitude/Longitude	
				Start	End
Item	DWR UCIP Field Study			37.054547 °	37.054547 °
				-120.415826 °	-120.415826 °
DWR ID					
Comment Code					
Inspector Comment					
FS_ID:39923 DS_ID:25043 EP_NO: N/A Repair Type: Non-Urgent Crossing Status: Found UCIP Comments: Need to contact owner to determine status. Need permit authorizing work. FIELD_STRUCT_DESC: 5-inch steel conduit along bridge downstream face. Upstream face has 2-inch pipe cut at the corner. FS Date: 5/6/2014

Conduit along face of bridge.

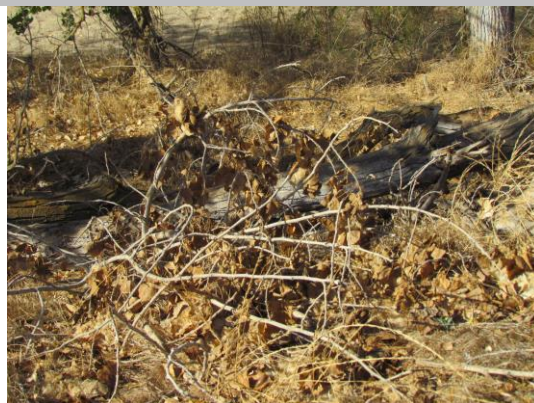
Photo 1 of 2 : FA_2016_NA0011_143_27_20161011_00037.jpg

LM Start	0.98	Rating **	U	Issue No.	27
LM End	0.98	Issue Type +	En	Location *	WS
Category	Earthen Levee			GPS Latitude/Longitude	
				Start	End
Item	Encroachments			37.054928 °	37.054928 °
				-120.415482 °	-120.415482 °
DWR ID	DWR_NA0011_02_f_2016_27				
Comment Code					
TR : Tree or limb					
Inspector Comment					
Remove the dead tree from the waterside slope ans shoulder.

Unit 2 Ash Slough Levee mile 0.98 waterside shoulder and slope

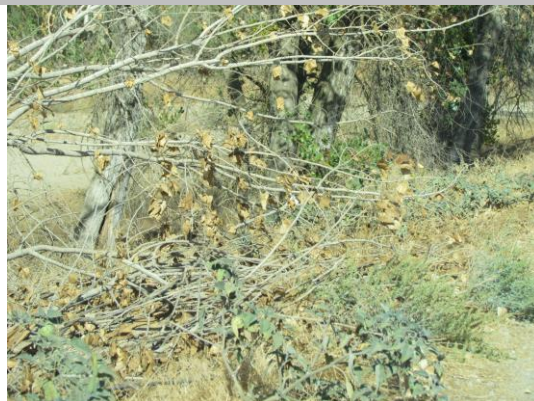
Photo 2 of 2 : FA_2016_NA0011_143_27_20161011_00038.jpg

LM Start	0.98	Rating **	U	Issue No.	27 (cont)
LM End	0.98	Issue Type +	En	Location *	WS

Levee slope and shoulder looking upstream waterside levee section.

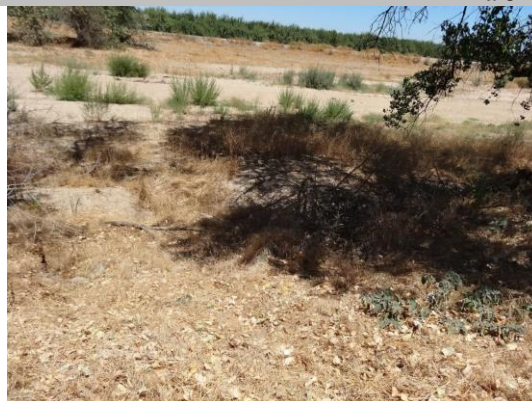
Photo 1 of 3 : SJR2016_NA0011U02RM2.57_1.jpg

LM Start	1.10	Rating **	U	Issue No.	1 (cont)
LM End	1.19	Issue Type +	Ma	Location *	WS

View of the erosion site from the levee crest.

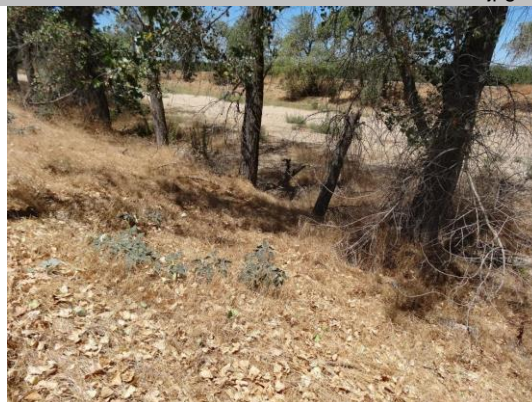
Photo 2 of 3 : SJR2016_NA0011U02RM2.57_2.jpg

Close view of the site.

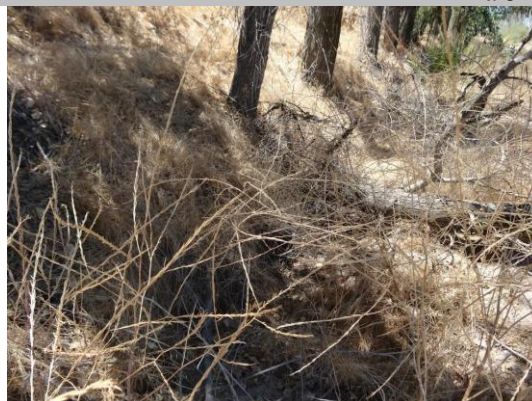
Photo 3 of 3 : SJR2016_NA0011U02RM2.57_4.jpg

9/6/2007: Undercutting of the toe; several trees along the WS slope with roots exposed. [2016 Site ID:NA0011U02RM2.57]

Close view of the site.

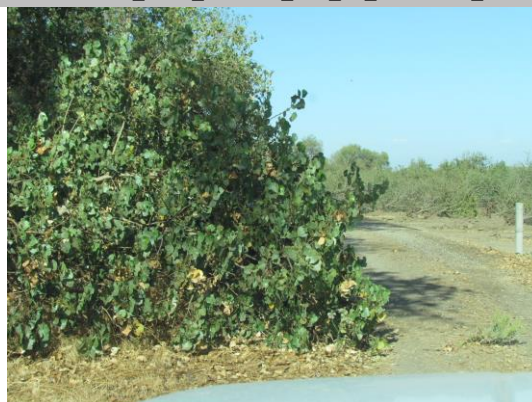
Photo 1 of 1 : FA_2016_NA0011_143_29_20161011_00035.jpg

LM Start	1.23	Rating **	U	Issue No.	29	
LM End	1.23	Issue Type +	Ma	Location *	WS	
Category	Earthen Levee			GPS Latitude/Longitude		
				Start		End
Item	Trim / Thin Trees			37.056137 °		37.056137 °
				-120.411170 °		-120.411170 °
DWR ID	DWR_NA0011_02_f_2016_29					
Comment Code						
T3 : Trim and thin trees to allow visibility of the ground and room to flood fight.						
Inspector Comment						
Tree on the wateside slope blocks the view of the ground.

Unit 2 Ash Slough wateside levee mile 1.23.

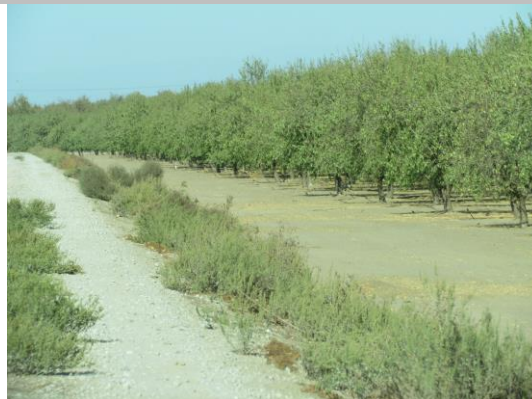
Photo 1 of 1 : FA_2016_NA0011_143_6_20161011_00034.jpg

LM Start	1.64	Rating **	U	Issue No.	6
LM End	2.02	Issue Type +	Ma	Location *	LS
Category	Earthen Levee			GPS Latitude/Longitude	
				Start	End
Item	Vegetation			37.059777 °	37.063896 °
				-120.405663 °	-120.401230 °
DWR ID	DWR_NA0011_02_f_2016_6				
Comment Code					
V2 : Remove the wild growth other than native grasses from the levee slopes.					
Inspector Comment					
Remove the dead weed growth from the landside levee slope.

Unit 2 looking upstream from levee mile 1.64 Crown roadway.

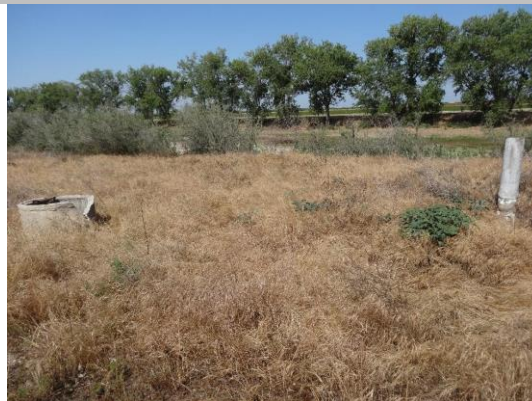
Photo 1 of 2 : UCIP_FA_2016_39925_71815.jpg

LM Start	2.02	Rating **	M	Issue No.	51
LM End	2.02	Issue Type +	En	Location *	LS
Category	Supplemental			GPS Latitude/Longitude	
				Start	End
Item	DWR UCIP Field Study			37.063982 °	37.063982 °
				-120.401165 °	-120.401165 °
DWR ID					
Comment Code					
Inspector Comment					
FS_ID:39925					
DS_ID:25045					
EP_NO: N/A					
Repair Type: Non-Urgent					
Crossing Status: Indicator Found					
UCIP Comments: Need to contact owner to determine additional information about crossing and potential appurtenances.					
FIELD_STRUCT_DESC: 36-inch filled with concrete.					
FS Date: 5/6/2014

Standpipes visible on waterward side.

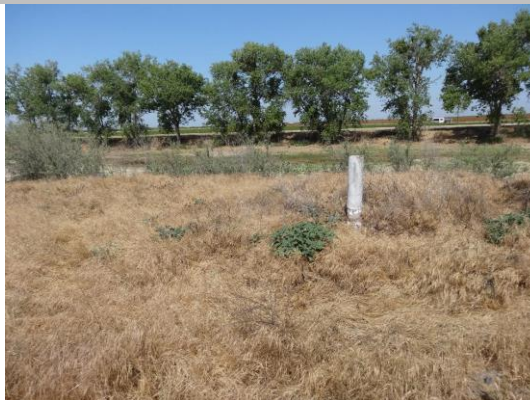
Photo 1 of 2 : UCIP_FA_2016_39924_71809.jpg

LM Start	2.03	Rating **	M	Issue No.	50
LM End	2.03	Issue Type +	En	Location *	LS
Category	Supplemental			GPS Latitude/Longitude	
				Start	End
Item	DWR UCIP Field Study			37.064087 °	37.064087 °
				-120.401194 °	-120.401194 °
DWR ID					
Comment Code					
Inspector Comment					
FS_ID:39924 DS_ID:25044 EP_NO: N/A Repair Type: Non-Urgent Crossing Status: Found UCIP Comments: Need to contact owner to determine status. FIELD_STRUCT_DESC: 10-inch pipes located on waterward side. FS Date: 5/6/2014

Tall concrete standpipe visible on waterward side.

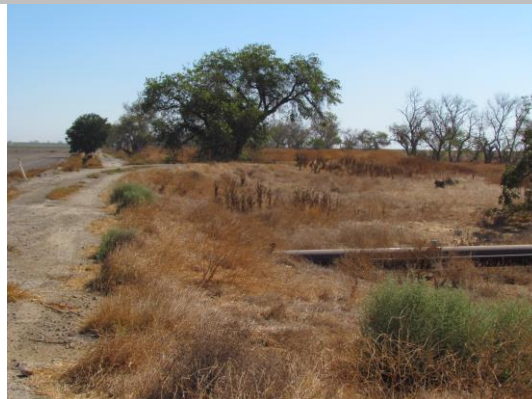
Photo 1 of 1 : FA_2016_NA0011_144_1_20161011_00015.jpg

LM Start	0.00	Rating **	U	Issue No.	1
LM End	1.04	Issue Type +	Ma	Location *	WS
Category	Earthen Levee			GPS Latitude/Longitude	
				Start	End
Item	Vegetation			36.996562 °	36.996592 °
				-120.373748 °	-120.355160 °
DWR ID	DWR_NA0011_03_s_2013_1				
Comment Code					
V2 : Remove the wild growth other than native grasses from the levee slopes.					
Inspector Comment					
Remove the unwanted tumble weeds and other weeds from the wateside levee slope.

Berenda Slough Unit 3 levee mile 0.00 looking upstream from the wateside slope.

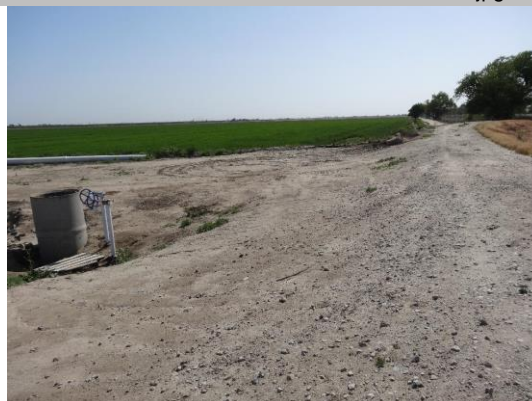
Photo 1 of 2 : UCIP_FA_2016_35767_64476.jpg

LM Start	0.00	Rating **	M	Issue No.	46
LM End	0.00	Issue Type +	En	Location *	WS
Category	Supplemental			GPS Latitude/Longitude	
				Start	End
Item	DWR UCIP Field Study			36.996593 °	36.996593 °
				-120.373636 °	-120.373636 °
DWR ID					
Comment Code					
Inspector Comment					
FS_ID:35767					
DS_ID:21516					
EP_NO: N/A					
Repair Type: Non-Urgent					
Crossing Status: Found					
UCIP Comments: Unable to confirm if crossing is still being used. Need to contact owner to determine status of crossing.					
FIELD_STRUCT_DESC: 18-inch steel pipe through levee at unknown depth. Levee log records indicate the abandonment of the Chowchilla Canal Siphon was backfilled through the levee section. Pipe through levee slant pump on waterward slope.					
FS Date: 5/6/2014

View of landward side.

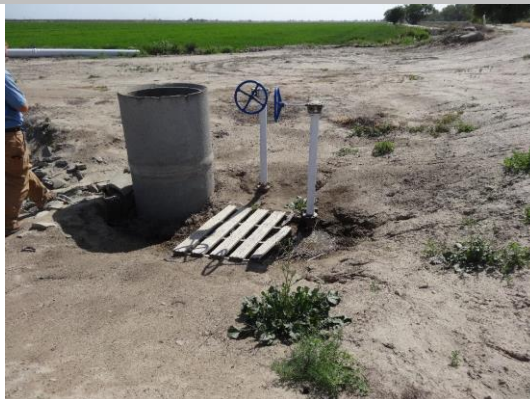
Photo 2 of 2 : UCIP_FA_2016_35767_64475.jpg

LM Start	0.00	Rating **	M	Issue No.	46 (cont)	
LM End	0.00	Issue Type +	En	Location *	WS	
Category	Supplemental			GPS Latitude/Longitude		
				Start	End	
Item	DWR UCIP Field Study			36.996593 °	36.996593 °	
				-120.373636 °	-120.373636 °	
DWR ID						
Comment Code						
Inspector Comment						
FS_ID:35767						
DS_ID:21516						
EP_NO: N/A						
Repair Type: Non-Urgent						
Crossing Status: Found						
UCIP Comments: Unable to confirm if crossing is still being used. Need to contact owner to determine status of crossing.						
FIELD_STRUCT_DESC: 18-inch steel pipe through levee at unknown depth. Levee log records indicate the abandonment of the Chowchilla Canal Siphon was backfilled through the levee section. Pipe through levee slant pump on waterward slope.						
FS Date: 5/6/2014

Close up of concrete standpipe and multiple positive closure devices.

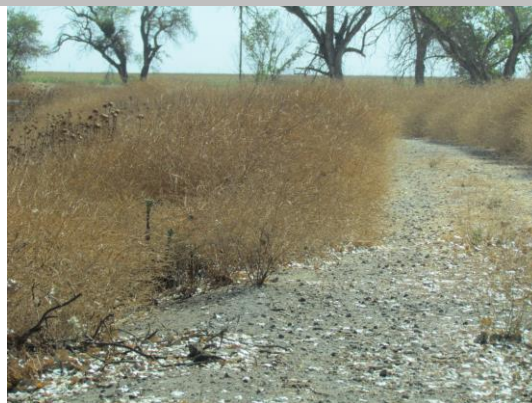
Photo 1 of 1 : FA_2016_NA0011_144_5_20161011_00021.jpg

LM Start	0.05	Rating **	U	Issue No.	5
LM End	1.51	Issue Type +	Ma	Location *	LS
Category	Earthen Levee			GPS Latitude/Longitude	
				Start	End
Item	Vegetation			36.996453 °	36.996607 °
				-120.372898 °	-120.346568 °
DWR ID	DWR_NA0011_03_f_2016_5				
Comment Code					
V2 : Remove the wild growth other than native grasses from the levee slopes.					
Inspector Comment					
Remove the tall dead weed growth from the landside of the levee slope and shoulder.

Berenda Slough Unit 3 looking upstream from landside levee miles 0.05-1.51.

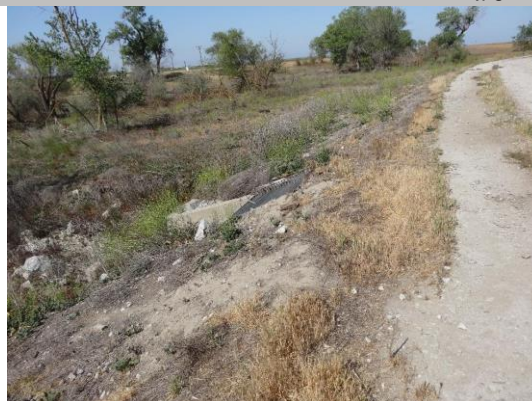
Photo 1 of 2 : UCIP_FA_2016_38228_69689.jpg

FS_ID:38228
DS_ID:21517
EP_NO: N/A
Repair Type: Non-Urgent
Crossing Status: Found
UCIP Comments: Need to contact owner to determine status of crossing. Unable to determine if crossing is in use.
FIELD_STRUCT_DESC: 36-inch CM pipe through the levee, 7.3 feet below the crown. Headwalls and wing walls on both ends. Flap gate on waterward end.
FS Date: 5/6/2014

View of waterward side.

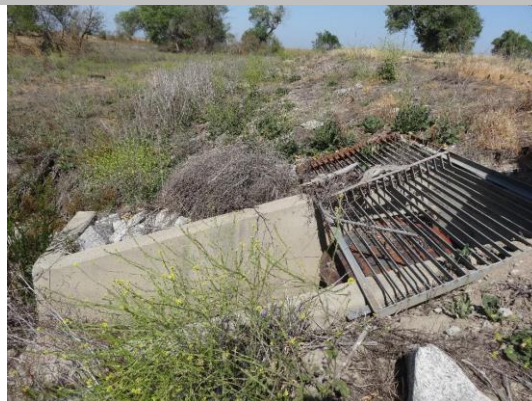
Photo 2 of 2 : UCIP_FA_2016_38228_69687.jpg

Debris screen visible on waterward headwall.

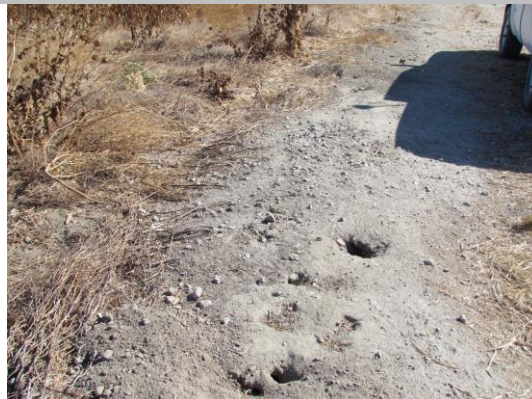
Photo 1 of 2 : FA_2016_NA0011_144_6_20161011_00016.jpg

LM Start	0.40	Rating **	U	Issue No.	6
LM End	1.51	Issue Type +	Ma	Location *	LS
Category	Earthen Levee			GPS Latitude/Longitude	
				Start	End
Item	Animal Control			36.996208 °	36.996607 °
				-120.366550 °	-120.346568 °
DWR ID	DWR_NA0011_03_f_2016_6				
Comment Code					
A1 : Exterminate rodents and backfill and compact or grout burrows.					
Inspector Comment					
There need to be rodent bait stations placed along the levee section landside slope and or shoulder at levee miles listed.

Berenda Slough Unit 3 levee miles 0.40-1.51 landside shoulder and slope.

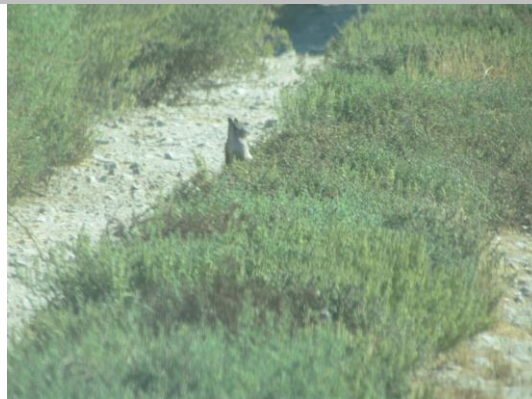
Photo 1 of 1 : FA_2016_NA0011_144_8_20161011_00022.jpg

LM Start	0.71	Rating **	M	Issue No.	8
LM End	1.51	Issue Type +	Ma	Location *	CR
Category	Earthen Levee			GPS Latitude/Longitude	
				Start	End
Item	Animal Control			36.996257 °	36.996607 °
				-120.361025 °	-120.346568 °
DWR ID	DWR_NA0011_03_f_2016_8				
Comment Code					
A1 : Exterminate rodents and backfill and compact or grout burrows.					
Inspector Comment					
Exterminate rodents from the crown roadway in the area listed. Active rodents observed during inspection at this site.

Berenda Slough Unit 3 looking upstream from levee miles 0.71 - to 1.51.

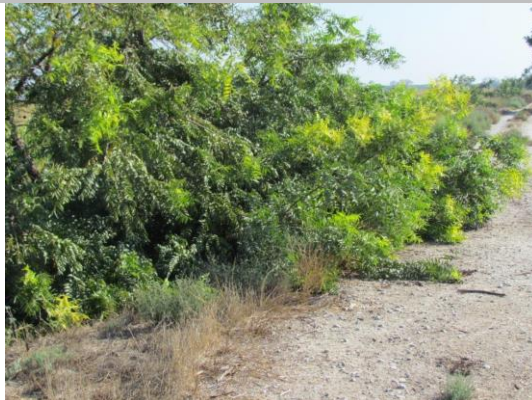
Photo 1 of 1 : FA_2016_NA0011_144_11_20161004_00003.jpg

LM Start	1.04	Rating **	U	Issue No.	11
LM End	1.05	Issue Type +	Ma	Location *	LS
Category	Earthen Levee			GPS Latitude/Longitude	
				Start	End
Item	Trim / Thin Trees			36.996613 °	36.996610 °
				-120.355055 °	-120.354995 °
DWR ID	DWR_NA0011_03_s_2012_11				
Comment Code					
T1 : Trim trees to at least five feet above ground level.					
Inspector Comment					
These walnut trees are blocking the view and inspection of the landside levee shoulder and slope. Cut them back in order that the ground can be seen.

Berenda Slough Unit 3 looking upstream from levee mile 1.04-1.05 walnut trees blocking the view of the landside levee section.

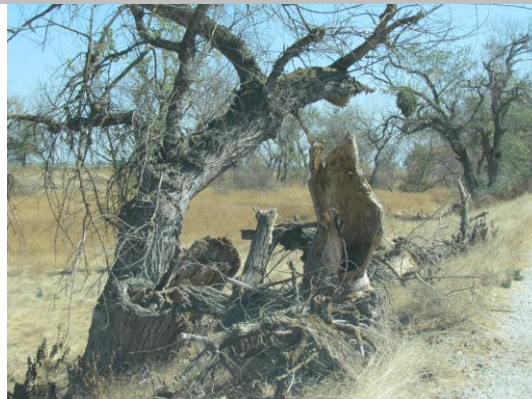
Photo 1 of 1 : FA_2016_NA0011_145_15_20161011_00019.jpg

LM Start	0.14	Rating **	U	Issue No.	15
LM End	0.14	Issue Type +	Ma	Location *	CR
Category	Earthen Levee			GPS Latitude/Longitude	
				Start	End
Item	Encroachments			36.995528 °	36.995528 °
				-120.370922 °	-120.370922 °
DWR ID	DWR_NA0011_04_f_2015_15				
Comment Code					
TR : Tree or limb					
Inspector Comment					
There are many dead trees in the area. This one happened to be blocking the crown roadway. Remove the dead trees from the levee section. Many more are subject to fall and further block access to the levee crown.

Berenda Slough looking upstream from the levee mile 0.14.

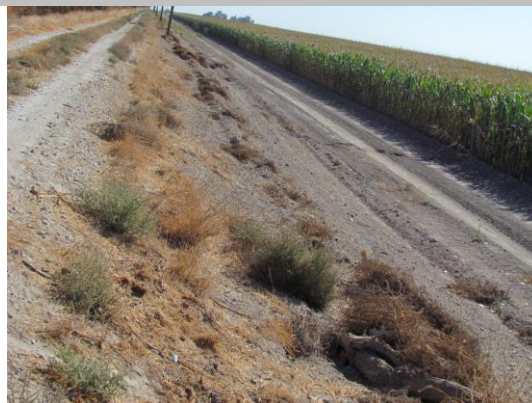
Photo 1 of 1 : FA_2016_NA0011_145_3_20161011_00020.jpg

LM Start	0.14	Rating **	U	Issue No.	3
LM End	0.97	Issue Type +	Ma	Location *	LS
Category	Earthen Levee			GPS Latitude/Longitude	
				Start	End
Item	Slope Stability			36.995543 °	36.995550 °
				-120.370907 °	-120.355935 °
DWR ID	DWR_NA0011_04_f_2016_3				
Comment Code					
S1 : Repair slope instability.					
Inspector Comment					
The slope in this area has been damaged by farm equipment on the slope.

Berenda Slough Unit 4 Looking upstream from levee mile 0.14-0.97.

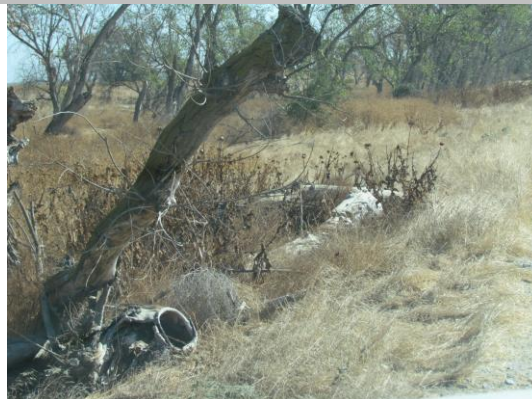
Photo 1 of 1 : FA_2016_NA0011_145_16_20161011_00021.jpg

LM Start	0.47	Rating **	U	Issue No.	16
LM End	0.47	Issue Type +	Ma	Location *	WS
Category	Earthen Levee			GPS Latitude/Longitude	
				Start	End
Item	Encroachments			36.995603 °	36.995603 °
				-120.364978 °	-120.364978 °
DWR ID	DWR_NA0011_04_s_2014_16				
Comment Code					
TR : Tree or limb					
Inspector Comment					
This dead tree on water ward slope should be removed from levee section.

Berenda Slough Unit 4 levee mile 0.47 looking back upstream.

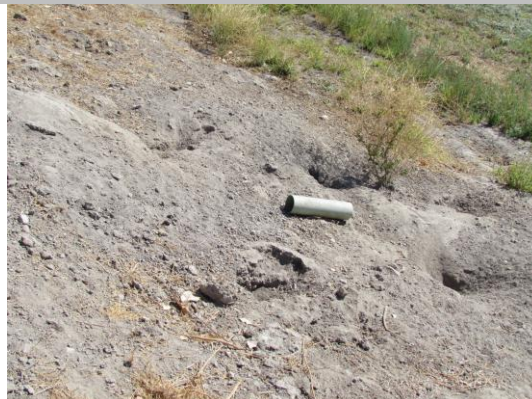
Photo 1 of 3 : FA_2016_NA0011_145_11_20161011_00022.jpg

LM Start	0.62	Rating **	U	Issue No.	11
LM End	1.25	Issue Type +	Ma	Location *	LS
Category	Earthen Levee			GPS Latitude/Longitude	
				Start	End
Item	Animal Control			36.995568 °	36.995474 °
				-120.362303 °	-120.350890 °
DWR ID	DWR_NA0011_04_f_2016_11				
Comment Code					
A1 : Exterminate rodents and backfill and compact or grout burrows.					
Inspector Comment					
Exterminate the rodents and backfill and compact or grout the burrows in this area listed.

Berenda Slough landside slope levee miles 0.62-1.25 looking upstream.

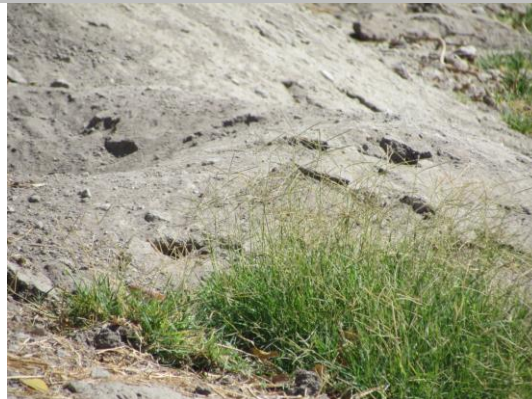
Photo 2 of 3 : FA_2016_NA0011_145_11_20161012_00027.jpg

Berenda Slough landside slope levee miles 0.62-1.25. looking upstream.

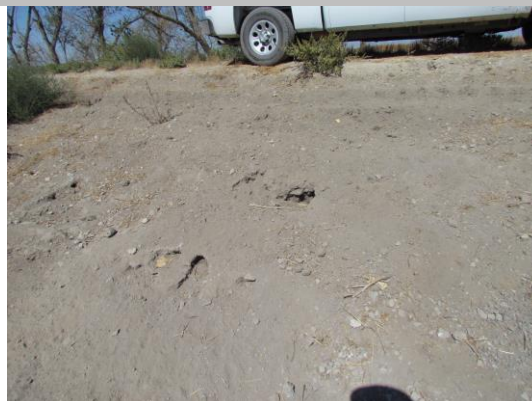
Photo 3 of 3 : FA_2016_NA0011_145_11_20161012_00028.jpg

LM Start	0.62	Rating **	U	Issue No.	11 (cont)	
LM End	1.25	Issue Type +	Ma	Location *	LS	
Category	Earthen Levee			GPS Latitude/Longitude		
				Start	End	
Item	Animal Control			36.995568 °	36.995474 °	
				-120.362303 °	-120.350890 °	
DWR ID	DWR_NA0011_04_f_2016_11					
Comment Code						
A1 : Exterminate rodents and backfill and compact or grout burrows.						
Inspector Comment						
Exterminate the rodents and backfill and compact or grout the burrows in this area listed.

This photo shows another view of the activity along the landside between the levee miles.

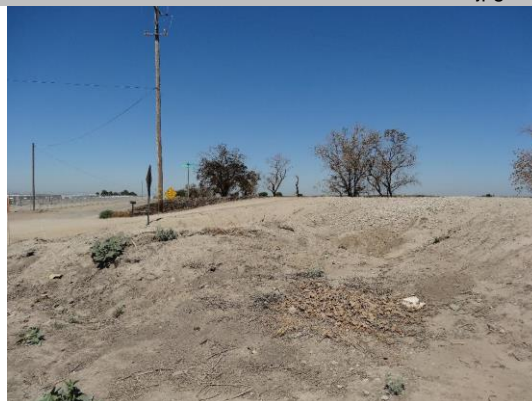
Photo 1 of 2 : UCIP_FA_2016_49977_75760.jpg

LM Start	1.50	Rating **	U	Issue No.	60
LM End	1.50	Issue Type +	En	Location *	LS
Category	Supplemental			GPS Latitude/Longitude	
				Start	End
Item	DWR UCIP Field Study			36.995597 °	36.995597 °
				-120.346418 °	-120.346418 °
DWR ID					
Comment Code					
Inspector Comment					
FS_ID:49977 DS_ID:25469 EP_NO: N/A Repair Type: Urgent Crossing Status: Found UCIP Comments: 7/14/2016 New entry added--pipe failure. Sink hole present on LS slope. Concrete headwall collapse visible on LS slope. Pipe buried on both WS and LS. (DWR UCIP - omagana) FIELD_STRUCT_DESC: Unknown size drainage pipe through the levee, approximately 5 feet below the crown. Concrete headwall located on the landside (LS). Corrugated metal pipe located on LS toe. Sluice gate is located on the waterside (WS). FS Date: 7/14/2016

View of LS slope.

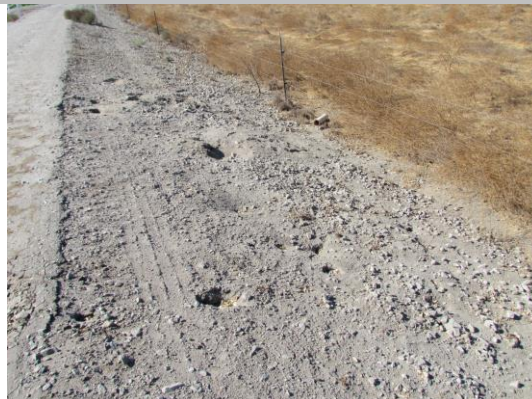
Photo 1 of 1 : FA_2016_NA0011_145_30_20161012_00031.jpg

LM Start	1.63	Rating **	U	Issue No.	30
LM End	2.23	Issue Type +	Ma	Location *	WS
Category	Earthen Levee			GPS Latitude/Longitude	
				Start	End
Item	Animal Control			36.996503 °	37.003308 °
				-120.344465 °	-120.337550 °
DWR ID	DWR_NA0011_04_f_2014_30				
Comment Code					
A1 : Exterminate rodents and backfill and compact or grout burrows.					
Inspector Comment					
Bait stations are needed in Rodent infested area waterside slope and toe.

Berenda Slough levee mile 1.63-2.23 looking upstream at waterside slope.

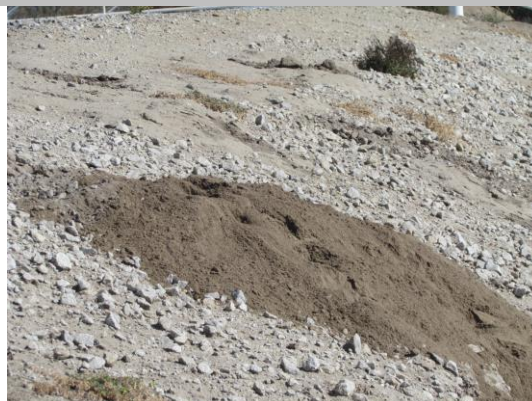
Photo 1 of 3 : FA_2016_NA0011_145_57_20161011_00023.jpg

LM Start	1.63	Rating **	U	Issue No.	57
LM End	2.23	Issue Type +	Ma	Location *	LS
Category	Earthen Levee			GPS Latitude/Longitude	
				Start	End
Item	Animal Control			36.996574 °	37.003328 °
				-120.344430 °	-120.337604 °
DWR ID	DWR_NA0011_04_s_2012_57				
Comment Code					
A1 : Exterminate rodents and backfill and compact or grout burrows.					
Inspector Comment					
The District really needs to do a better job of controlling the rodents. There should be bait stations with rodent bait in place. (2013).

Berenda Slough looking upstream landside slope.

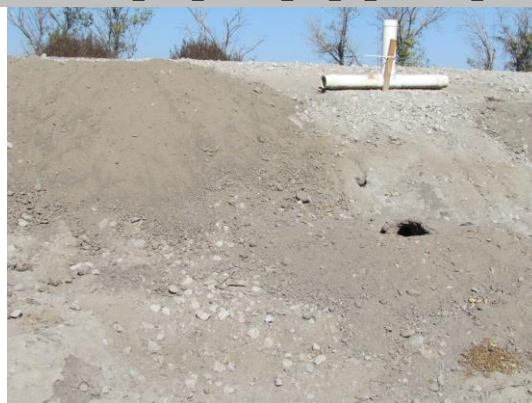
Photo 2 of 3 : FA_2016_NA0011_145_57_20161011_00026.jpg

More activity

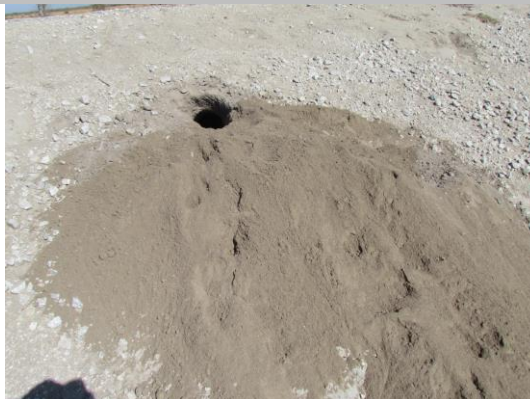
Photo 3 of 3 : FA_2016_NA0011_145_57_20161011_00025.jpg

LM Start	1.63	Rating **	U	Issue No.	57 (cont)	
LM End	2.23	Issue Type +	Ma	Location *	LS	
Category	Earthen Levee			GPS Latitude/Longitude		
				Start		End
Item	Animal Control			36.996574 °		37.003328 °
				-120.344430 °		-120.337604 °
DWR ID	DWR_NA0011_04_s_2012_57					
Comment Code						
A1 : Exterminate rodents and backfill and compact or grout burrows.						
Inspector Comment						
The District really needs to do a better job of controlling the rodents. There should be bait stations with rodent bait in place. (2013).

Activity on the landside slope between the levee mile 1.63 and 2.23.

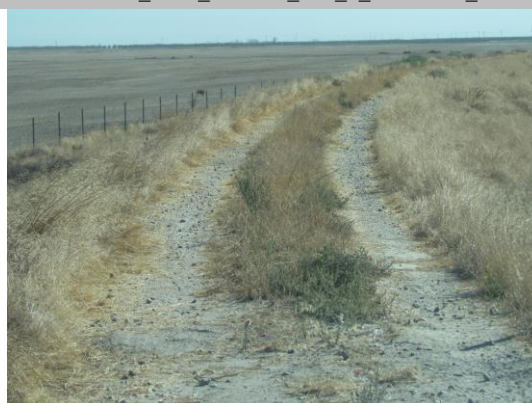
Photo 1 of 1 : FA_2016_NA0011_146_8_20161012_00020.jpg

LM Start	0.00	Rating **	U	Issue No.	8
LM End	4.05	Issue Type +	Ma	Location *	CR
Category	Earthen Levee		GPS Latitude/Longitude		
			Start	End	
Item	Vegetation		36.978557 °	36.968152 °	
			-120.368423 °	-120.301103 °	
DWR ID	DWR_NA0011_05_f_2015_8				
Comment Code					
V9 : Keep the crown roadway free of vegetation.					
Inspector Comment					
The crown roadway must be free of all vegetation.

Fresno River looking upstream levee mile 0.00.

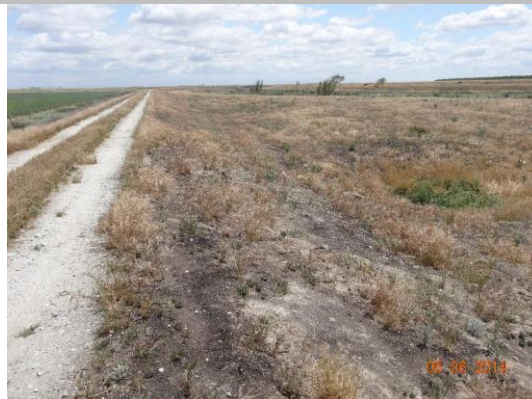
Photo 1 of 2 : UCIP_FA_2016_35795_64567.jpg

LM Start	0.18	Rating **	M	Issue No.	38
LM End	0.18	Issue Type +	En	Location *	CR
Category	Supplemental			GPS Latitude/Longitude	
				Start	End
Item	DWR UCIP Field Study			36.978036 °	36.978036 °
				-120.365246 °	-120.365246 °
DWR ID					
Comment Code					
Inspector Comment					
FS_ID:35795 DS_ID:21520 EP_NO: N/A Repair Type: Non-Urgent Crossing Status: Found UCIP Comments: Need to contact owner. Dense vegetation limits the inspector's visibility to identify signs of pipe failure (leaks) along the landward slope. Recommend removing vegetation along pipe alignment to conduct proper inspection of structure. FIELD_STRUCT_DESC: 36-inch CM pipe through the levee, 10.8 feet below the crown. Headwalls and wing walls on both ends. Flap gate on waterward end. FS Date: 5/6/2014

View of waterward side.

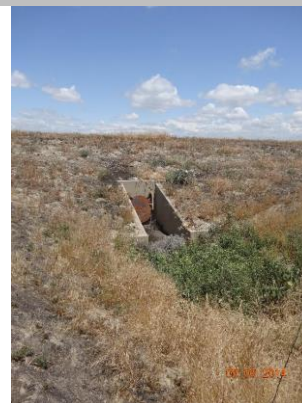
Photo 2 of 2 : UCIP_FA_2016_35795_64566.jpg

View of flap gate and concrete headwall located on waterward side.

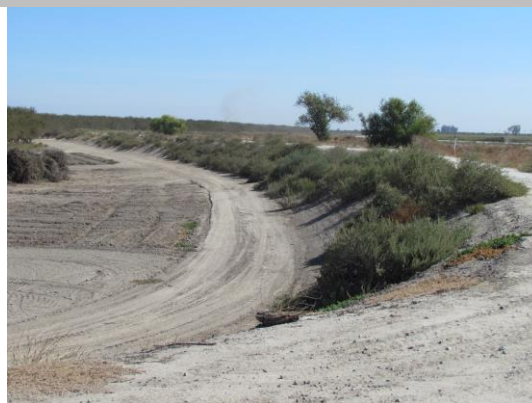
Photo 1 of 1 : FA_2016_NA0011_146_26_20161012_00024.jpg

LM Start	6.58	Rating **	U	Issue No.	26
LM End	7.54	Issue Type +	Ma	Location *	LS
Category	Earthen Levee			GPS Latitude/Longitude	
				Start	End
Item	Vegetation			36.968525 °	36.969527 °
				-120.255387 °	-120.238255 °
DWR ID	DWR_NA0011_05_f_2016_26				
Comment Code					
V1 : Control annual grass and weeds on the levee slopes and easements.					
Inspector Comment					
Control the wild growth of Tumble weeds from the landside slope and levee toe.

Fresno River looking upstream oof the landside levee slope miles 6.58-7.54.

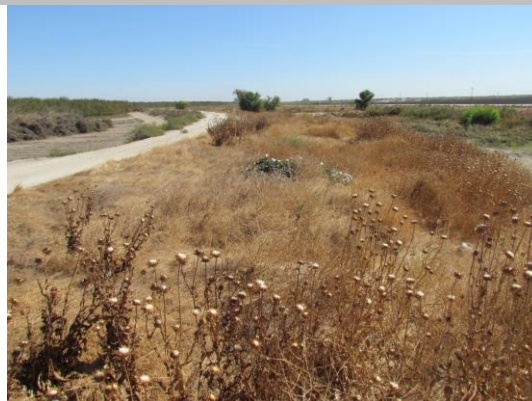
Photo 1 of 1 : FA_2016_NA0011_146_27_20161012_00025.jpg

LM Start	6.58	Rating **	U	Issue No.	27
LM End	9.07	Issue Type +	Ma	Location *	WS
Category	Earthen Levee			GPS Latitude/Longitude	
				Start	End
Item	Vegetation			36.968525 °	36.973197 °
				-120.255387 °	-120.212085 °
DWR ID	DWR_NA0011_05_f_2016_27				
Comment Code					
V2 : Remove the wild growth other than native grasses from the levee slopes.					
Inspector Comment					
Remove the wild dead weeds from he levee slope and toe.

Fresno River looking upstream waterside levee mile 6.58-9.07.

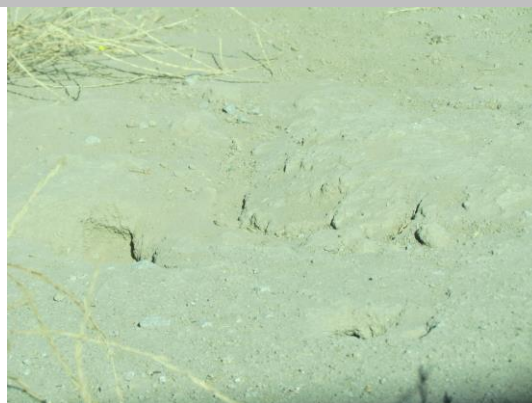
Photo 1 of 2 : FA_2016_NA0011_146_28_20161012_00021.jpg

LM Start	6.75	Rating **	U	Issue No.	28
LM End	6.95	Issue Type +	Ma	Location *	LS
Category	Earthen Levee			GPS Latitude/Longitude	
				Start	End
Item	Animal Control			36.969200 °	36.969507 °
				-120.252462 °	-120.248893 °
DWR ID	DWR_NA0011_05_f_2016_28				
Comment Code					
A1 : Exterminate rodents and backfill and compact or grout burrows.					
Inspector Comment					
Exterminate the rodents in the area listed and place bait stations along the shoulder and or slope.

Fresno River landside slope looking upstream of levee mile 6.75 -6.95.

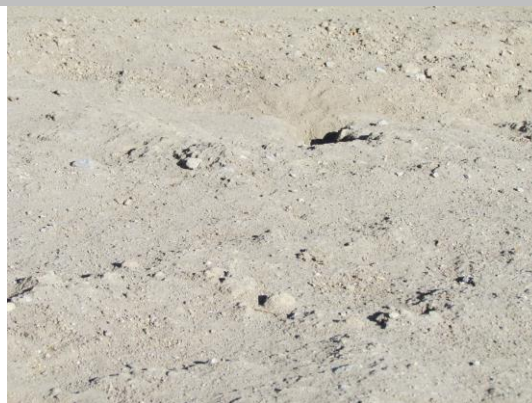
Photo 2 of 2 : FA_2016_NA0011_146_28_20161012_00023.jpg

LM Start	6.75	Rating **	U	Issue No.	28 (cont)
LM End	6.95	Issue Type +	Ma	Location *	LS

Fresno River looking upstream of the landside slope levee miles 6.76-6.95.

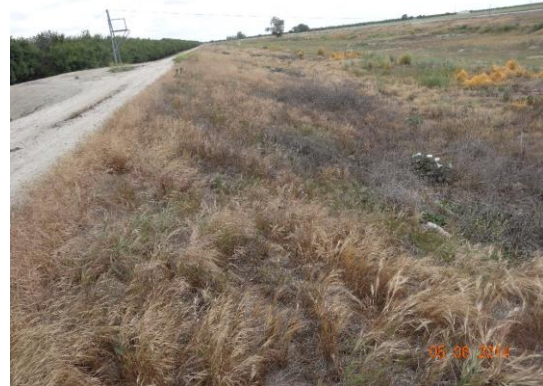
Photo 1 of 2 : UCIP_FA_2016_39006_69715.jpg

Comment Code					
Inspector Comment					
FS_ID:39006					
DS_ID:21527					
EP_NO: N/A					
Repair Type: Non-Urgent					
Crossing Status: Found					
UCIP Comments: Need to contact owner. Dense vegetation limits the inspector's visibility to identify signs of pipe failure (leaks) along the waterward slope. Recommend removing vegetation along pipe alignment to conduct proper inspection of structure and appurtenances. Slide gate buried on landward side. Recommend clearing sediment deposit on landward side.					
FIELD_STRUCT_DESC: 30-inch CM pipe through levee, 9.4 feet below the crown. Headwalls and wingwalls on both ends. Slide gate on landward end. Flap gate on waterward end.					
FS Date: 5/6/2014

View of waterward side.

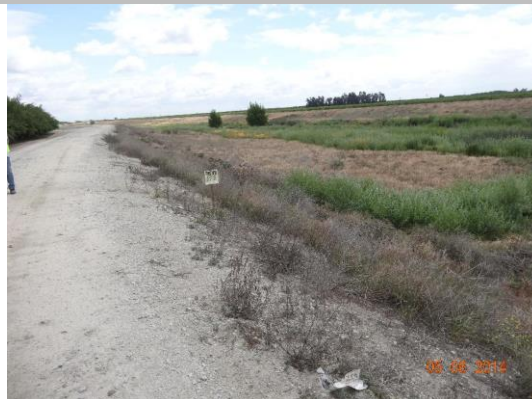
Photo 1 of 2 : UCIP_FA_2016_38235_69719.jpg

LM Start	8.09	Rating **	M	Issue No.	39
LM End	8.09	Issue Type +	En	Location *	LS
Category	Supplemental			GPS Latitude/Longitude	
				Start	End
Item	DWR UCIP Field Study			36.972415 °	36.972415 °
				-120.229285 °	-120.229285 °
DWR ID					
Comment Code					
Inspector Comment					
FS_ID:38235 DS_ID:21528 EP_NO: N/A Repair Type: Non-Urgent Crossing Status: Found UCIP Comments: Need to contact owner. Dense vegetation limits the inspector's visibility to identify signs of pipe failure (leaks) along the waterward slope. Recommend removing vegetation along pipe alignment to conduct proper inspection of structure and appurtenances. FIELD_STRUCT_DESC: 30-inch CM pipe through levee, 8.3 feet below the levee crown. Headwalls and wingwalls on both ends. Flap gate on waterward end. FS Date: 5/6/2014

View of waterward side.

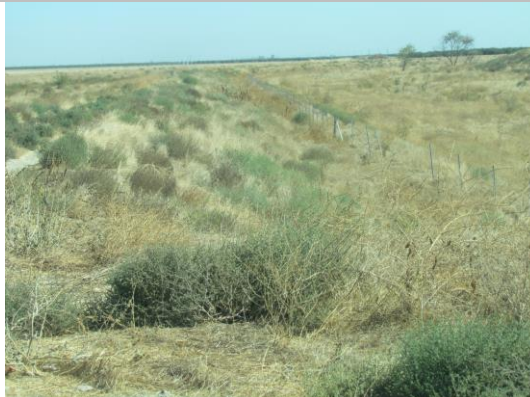
Photo 1 of 1 : FA_2016_NA0011_147_23_20161012_00028.jpg

LM Start	0.00	Rating **	U	Issue No.	23
LM End	2.48	Issue Type +	Ma	Location *	LS
Category	Earthen Levee			GPS Latitude/Longitude	
				Start	End
Item	Vegetation			36.976923 °	36.967223 °
				-120.367500 °	-120.328288 °
DWR ID	DWR_NA0011_06_f_2016_23				
Comment Code					
V1 : Control annual grass and weeds on the levee slopes and easements.					
Inspector Comment					
Remove the wild weed growth from the landward slope..

Fresno River looking upstream from the landside slope levee mile 0.00-2.48.

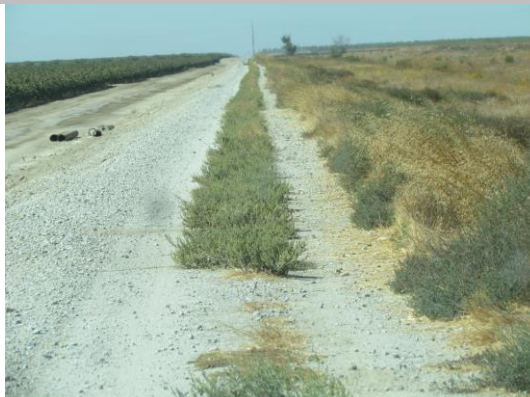
Photo 1 of 1 : FA_2016_NA0011_147_22_20161012_00029.jpg

LM Start	0.00	Rating **	U	Issue No.	22
LM End	5.88	Issue Type +	Ma	Location *	CR
Category	Earthen Levee			GPS Latitude/Longitude	
				Start	End
Item	Vegetation			36.976923 °	36.967508 °
				-120.367500 °	-120.266710 °
DWR ID	DWR_NA0011_06_f_2016_22				
Comment Code					
V9 : Keep the crown roadway free of vegetation.					
Inspector Comment					
Remove the weed growth from the crown roadway.

Fresno River looking downstream crown roadway levee mile 3.47.

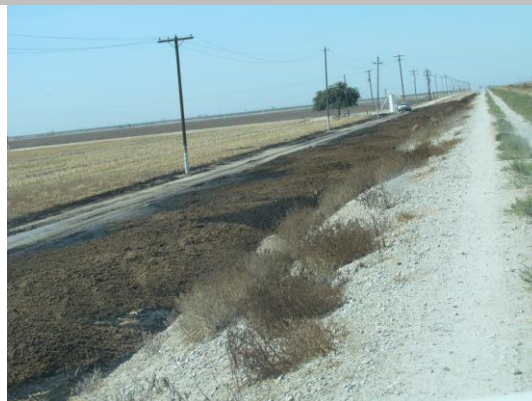
Photo 1 of 1 : FA_2016_NA0011_147_21_20161012_00032.jpg

LM Start	5.48	Rating **	U	Issue No.	21
LM End	5.71	Issue Type +	Ma	Location *	LS
Category	Earthen Levee			GPS Latitude/Longitude	
				Start	End
Item	Vegetation			36.967458 °	36.967458 °
				-120.273960 °	-120.269798 °
DWR ID	DWR_NA0011_06_f_2016_21				
Comment Code					
V2 : Remove the wild growth other than native grasses from the levee slopes.					
Inspector Comment					
Remove the wild growth of weeds from the landside slope.

Fresno River looking upstream from the landside slope levee mile 5.71.

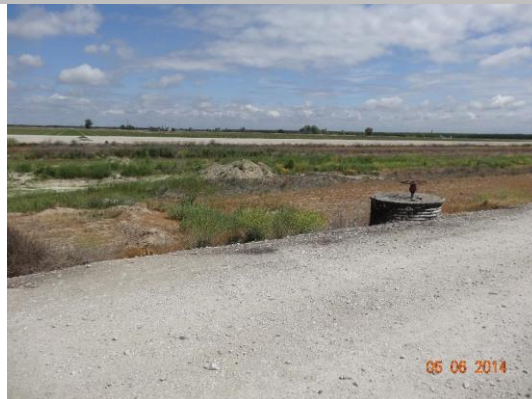
Photo 1 of 2 : UCIP_FA_2016_39008_64570.jpg

LM Start	6.17	Rating **	M	Issue No.	52
LM End	6.17	Issue Type +	En	Location *	LS
Category	Supplemental			GPS Latitude/Longitude	
				Start	End
Item	DWR UCIP Field Study			36.967568 °	36.967568 °
				-120.261594 °	-120.261594 °
DWR ID					
Comment Code					
Inspector Comment					
FS_ID:39008					
DS_ID:21531					
EP_NO: N/A					
Repair Type: Non-Urgent					
Crossing Status: Found					
UCIP Comments: Need to contact owner. Recommend removing sediment built up on landward side.					
FIELD_STRUCT_DESC: 48-inch CM pipe through levee, 11.5 feet below the crown. Slide gate on waterward shoulder. Headwalls and wingwalls on both ends. Flap gate on waterward end.					
FS Date: 5/6/2014

View of waterward side.

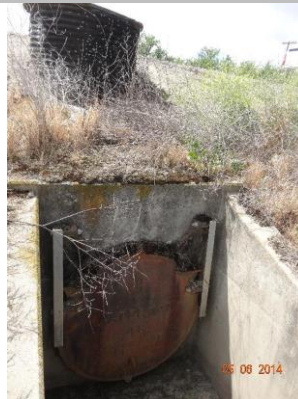
Photo 2 of 2 : UCIP_FA_2016_39008_64573.jpg

Flap gate, concrete headwall, and standpipe on waterward side.

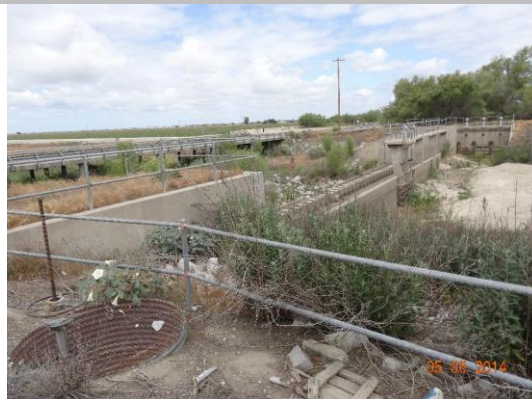
Photo 1 of 2 : UCIP_FA_2016_49980_69722.jpg

FS_ID:49980
DS_ID:21532
EP_NO: N/A
Repair Type: Non-Urgent
Crossing Status: Found
UCIP Comments: 7/14/2016 Same as previous inspection. Need to coordinate with owner. Need permit number authorizing work. (DWR UCIP - omagana)5/06/2014 Need to contact owner. Crossing on landward side appears to be modified--no headwall found on landward end. (DWR UCIP - omagana)
FIELD_STRUCT_DESC: 30-inch corrugated metal pipe through levee, 12 feet below the crown. Slide gate inside a 5-foot corrugated metal pipe riser located on the waterside (WS) shoulder. Headwalls and wingwalls are located on the WS end. Concrete headwall is located on the landside (LS) end. [Additional Reference(s): DWR Levee Log, 2005]
FS Date: 7/14/2016

View of WS.

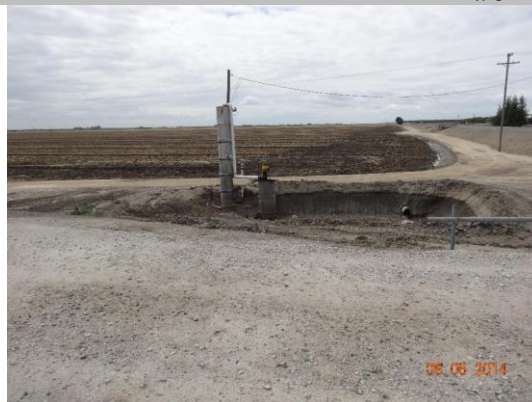
Photo 2 of 2 : UCIP_FA_2016_49980_69724.jpg

View of LS.

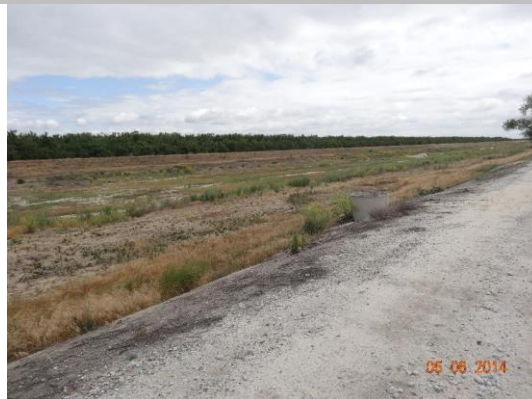
Photo 1 of 2 : UCIP_FA_2016_35804_64585.jpg

Comment Code					
Inspector Comment					
FS_ID:35804 DS_ID:21587 EP_NO: 13837 Repair Type: Non-Urgent Crossing Status: Found UCIP Comments: Need to contact owner. Dense vegetation limits the inspector's visibility to identify signs of pipe failure (leaks) along the waterward slope. Recommend removing vegetation along pipe alignment to conduct proper inspection of structure and appurtenances. FIELD_STRUCT_DESC: 12 inch diameter reinforced concrete pipe through levee at 7.5 feet below flood plane. The pipe line extends to a 27 inch concrete standpipe, located within the overflow area, through the levee section to a 30 inch diameter standpipe located on landward side. Positive closure device located on the waterward side. Walkway extends to positive closure device. (Permit No. 13837, Averill Ranch-1984) FS Date: 5/6/2014

View of waterward side.

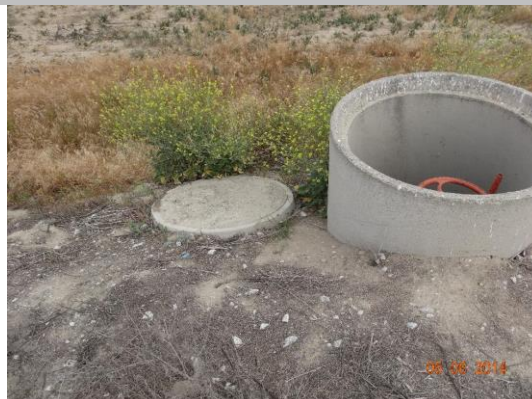
Photo 2 of 2 : UCIP_FA_2016_35804_64588.jpg

View of concrete standpipe and lid found on waterward shoulder.

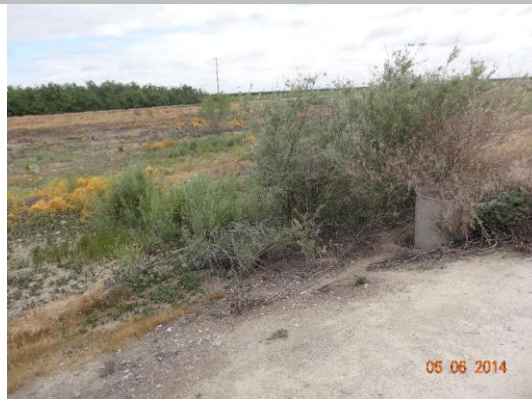
Photo 1 of 2 : UCIP_FA_2016_35805_64590.jpg

FS_ID:35805
DS_ID:21588
EP_NO: 13856
Repair Type: Non-Urgent
Crossing Status: Found
UCIP Comments: Need to contact owner. Dense vegetation limits the inspector's visibility to identify signs of pipe failure (leaks) along the waterward slope. Recommend removing vegetation along pipe alignment to conduct proper inspection of structure and appurtenances.
FIELD_STRUCT_DESC: 12 inch diameter gravity reinforced concrete irrigation pipe through levee approximately 4 feet below crown. The pipeline extend from a 24 inch diameter standpipe, located within the overflow area, through the levee section to a 36 inch diameter standpipe located on landward side. Positive closure device located on waterward side of the levee with an accessible walkway. (Permit No. 13856, Averill Ranch-1984)
FS Date: 5/6/2014

View of waterward side.

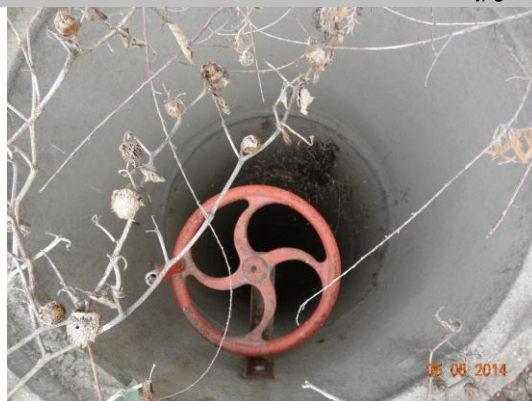
Photo 2 of 2 : UCIP_FA_2016_35805_64589.jpg

Inside view of standpipe located on waterward side.

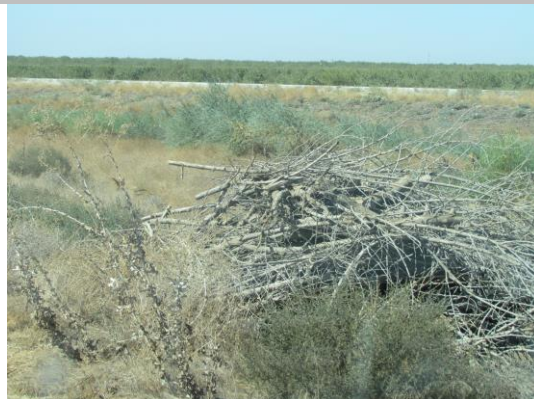
Photo 2 of 2 : FA_2016_NA0011_147_36_20161012_00034.jpg

LM Start	8.03	Rating **	U	Issue No.	36 (cont)	
LM End	8.03	Issue Type +	Ma	Location *	WS	
Category	Earthen Levee			GPS Latitude/Longitude		
				Start		End
Item	Encroachments			36.971582 °		36.971582 °
				-120.229180 °		-120.229180 °
DWR ID	DWR_NA0011_06_f_2015_36					
Comment Code						
TR : Tree or limb						
Inspector Comment						
The dead tree has been removed from blocking the roadway but still need to be removed from the levee section.

Fresno River levee mile 8.03 waterside slope and shoulder.

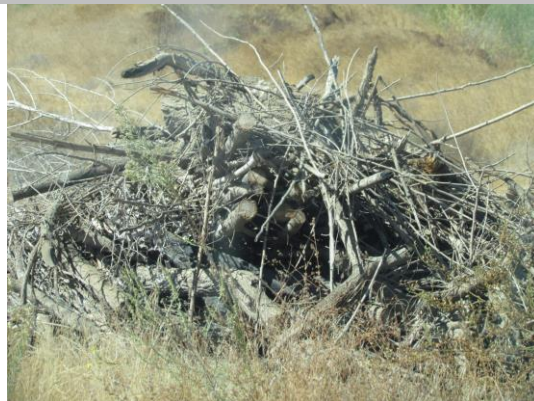
Photo 1 of 1 : FA_2016_NA0011_147_31_20161012_00033.jpg

LM Start	8.09	Rating **	U	Issue No.	31
LM End	8.09	Issue Type +	Ma	Location *	WS
Category	Earthen Levee			GPS Latitude/Longitude	
				Start	End
Item	Encroachments			36.971692 °	36.971692 °
				-120.227957 °	-120.227957 °
DWR ID	DWR_NA0011_06_f_2015_31				
Comment Code					
TR : Tree or limb					
Inspector Comment					
Remove the dead tree off the slope and shoulder, this has been reported in the last two inspections.

Fresno River levee mile 8.09.

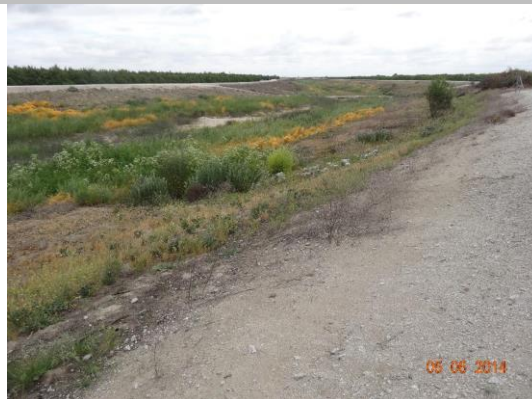
Photo 1 of 2 : UCIP_FA_2016_35806_64596.jpg

LM Start	8.53	Rating **	M	Issue No.	50
LM End	8.53	Issue Type +	En	Location *	LS
Category	Supplemental			GPS Latitude/Longitude	
				Start	End
Item	DWR UCIP Field Study			36.971462 °	36.971462 °
				-120.220276 °	-120.220276 °
DWR ID					
Comment Code					
Inspector Comment					
FS_ID:35806 DS_ID:21534 EP_NO: N/A Repair Type: Non-Urgent Crossing Status: Found UCIP Comments: Need to contact owner. Rip rap has been added around concrete headwall on waterward side--need to determine details for rip rap around structure. FIELD_STRUCT_DESC: 30-inch CM pipe through levee, 11.0 feet below crown. Headwalls and wingwalls on both ends. Flap gate on waterward end. FS Date: 5/6/2014

View of waterward side.
